Superfund Five-Year Review Report

Davie Landfill

Davie, Broward County, Florida

Prepared for
U.S. Environmental Protection Agency, Region IV
May 2000

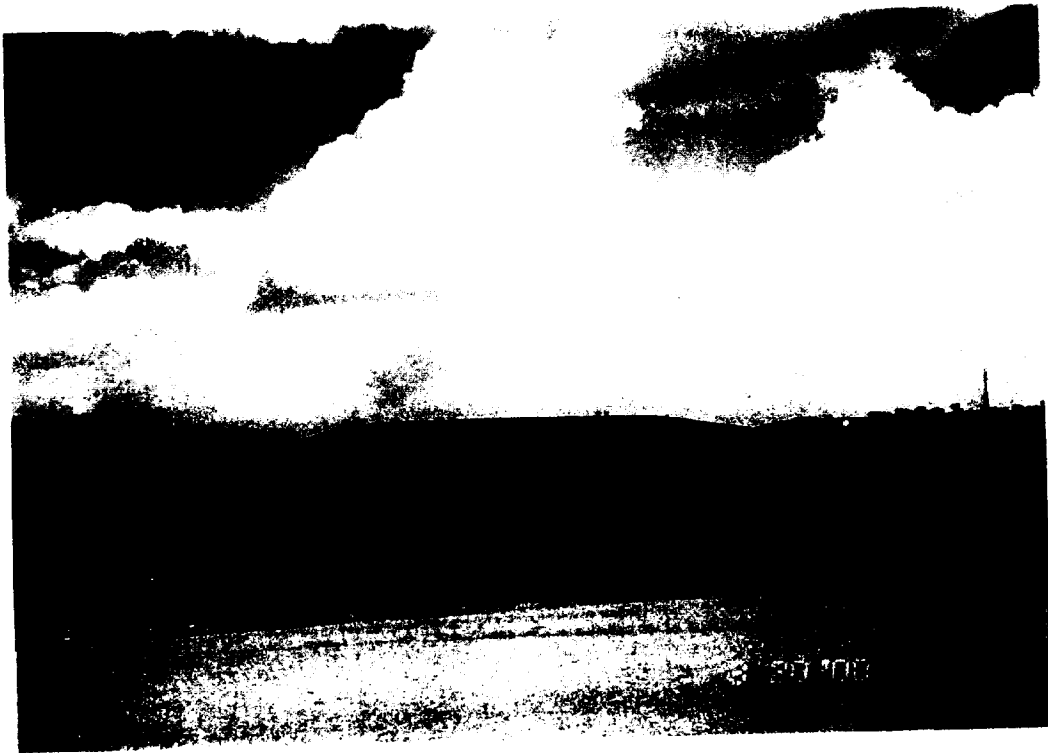
Photograph #1

Description: View of DLS behind bordering Dairy Farm. The Northmound is to the left and the Southmound is to the right [facing east, from shotgun rd.].

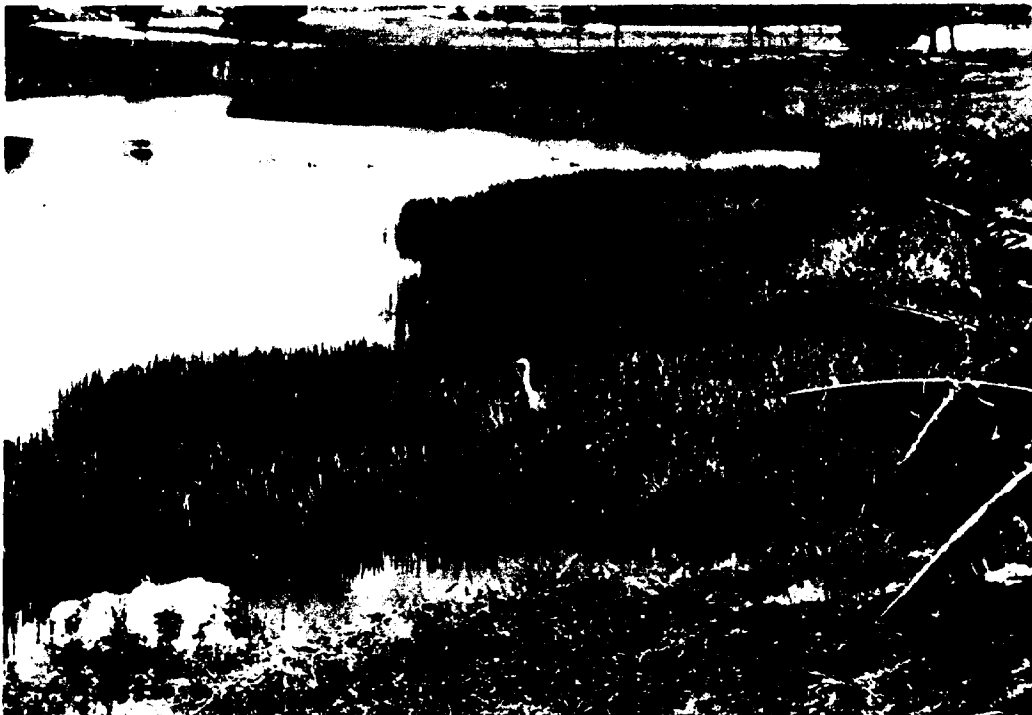
Photograph #2

Description: Nature pond (former Sluge lagoon) shows Egret and Ducks: [facing northeast].

Site Drainage Features. Surface water runoff collects in a series of three lakes, the pond and retention perimeter berms. Lake numbers 1, 2, and 3 all appear to be in good condition. The former sludge lagoon as noted in the first five-year review is still a thriving nature pond. The spillway channel from Lake 2 to Lake 3 was free of obstructions and appeared to be working as designed. The berms appeared to be in good condition. The sand trap was clean and in good condition. The site drainage culvert leading to the offsite ditch was also clean, free of debris and in good condition. Several Bass fish were observed in lakes 1 and 2.

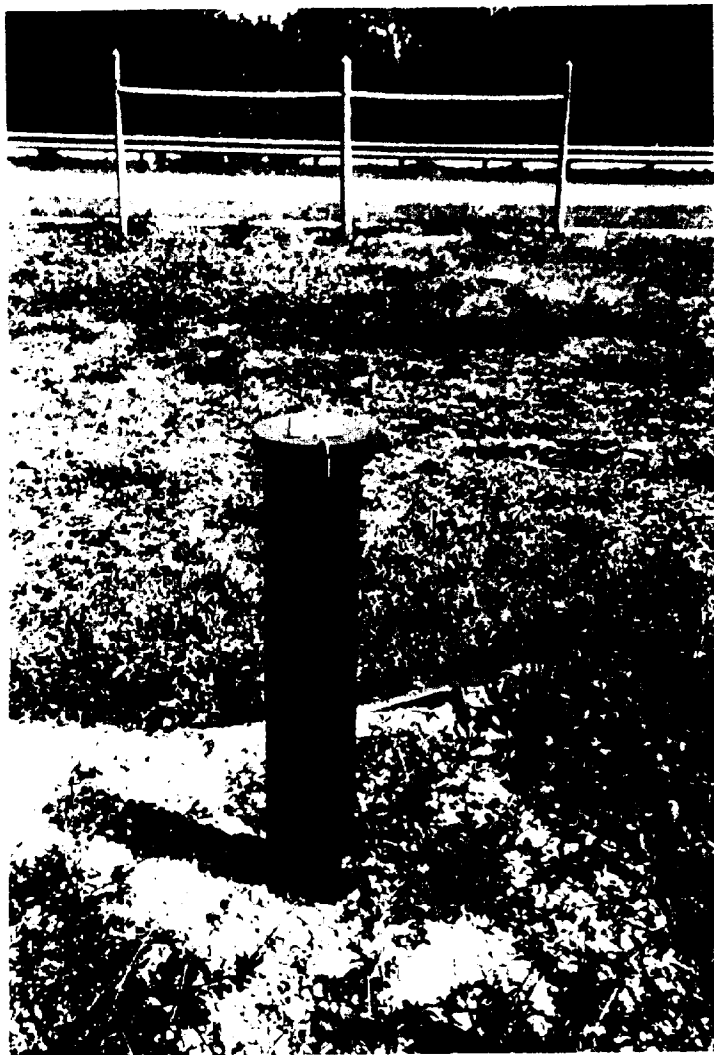
Photograph #3

Description: Close up of MW in cluster #8 shows locked protector casing: [*facing east, from east property boundary*].

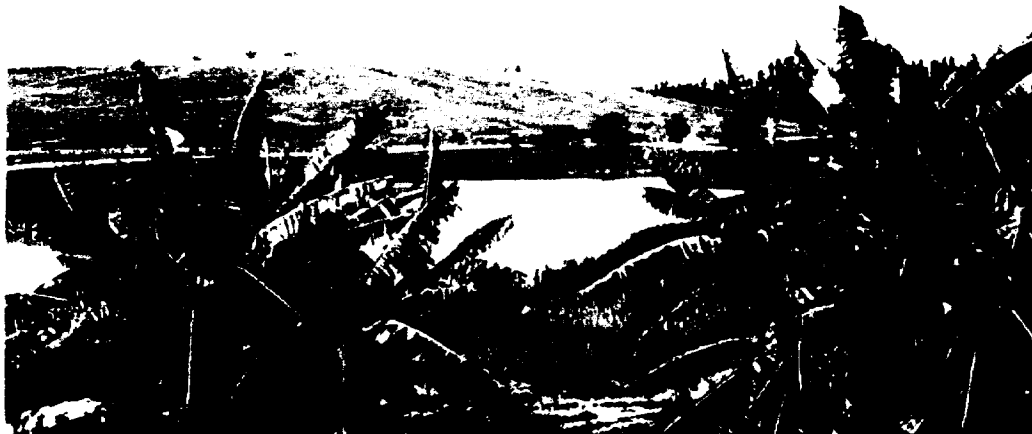
Photograph #4

Description: View of nature pond with north mound in background: *[facing northeast, from road]*.

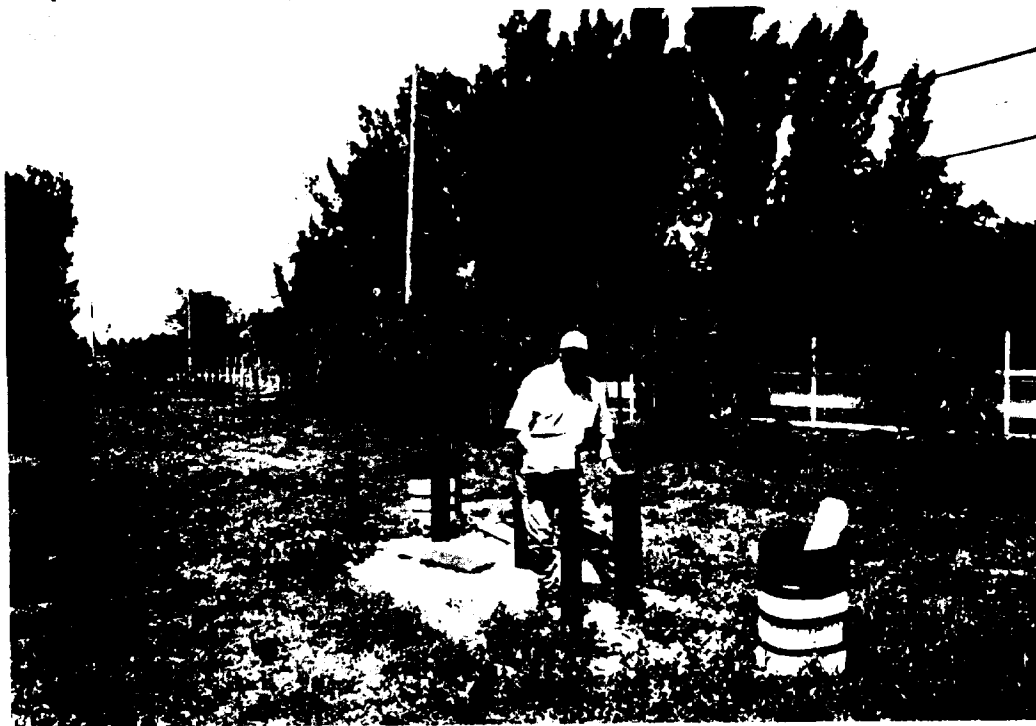
Photograph #5

Description: MW cluster #8, MWs are in good condition, clearly identified and are easily accessible: *[facing northeast, from cluster #8 next to Boy Scout Rd.]*.

Monitoring Wells. The monitoring wells observed appeared to be well identified and in good condition. The locks were also in good shape. MW cluster #11 is located on a sand rim and showed signs of settlement including cracked concrete around the base of the wells. Presently this does not affect the structure and integrity of the wells. However it should be monitored for any long-term change in condition.

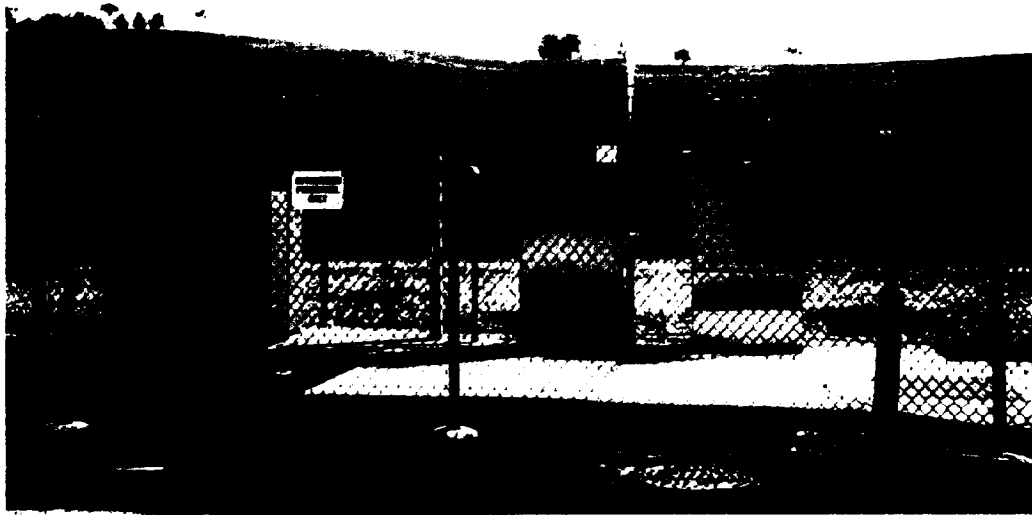
Photograph #6

Description: Main Leachate Sump Station with control panels: *[facing south, south mound in background].*

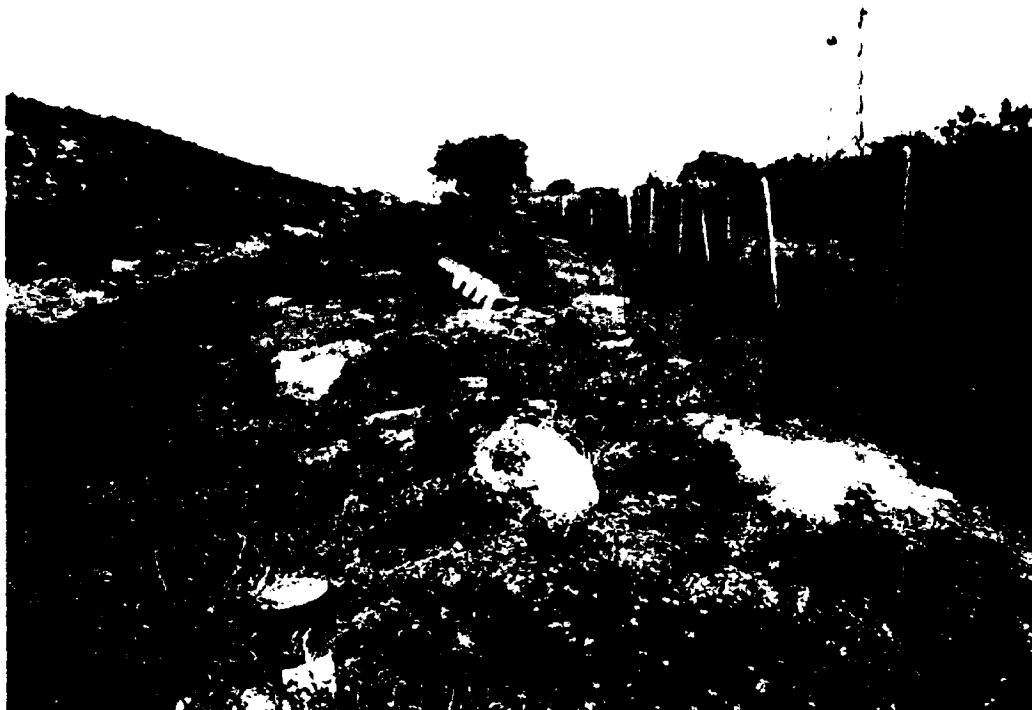
Photograph #7

B. Some settlement has occurred in the area, although this is not a short term problem, if not monitored properly it could develop into a long term one (IE. damage to Gas Recovery Wells, Leachate Lines, Monitoring Wells).

Description: MW cluster # 11, shows some settlement along berm: *[facing east, along southern border].*

B. Continue to monitor for any settlement changes (i.e. berms and landfill covers) and make adjustments or repairs as necessary in order to compensate.

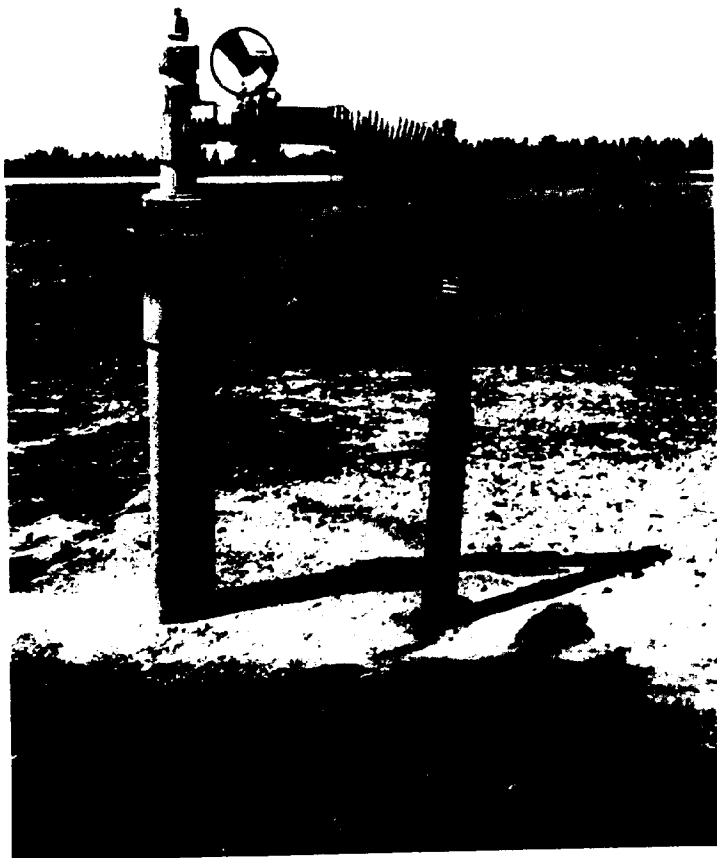
Photograph #8

Landfill Gas Control System. Several gas extraction wells were observed on the North Mound of the DLS. Some settlement has occurred in the area but appears to have not impacted the condition and operating efficiency of the wells. Presently, this is a long term impact situation that Broward County is aware of and continues to monitor. The Active Gas Flare System was observed to be locked and secure. The DLS gas collection system appears to be functioning adequately at this time. The Flare is currently run on a timer where it burns off landfill gas for six hours on and six hours off. Adjustments to the system can be made as needed, depending on the quantity and quality of landfill gases.

Description: Close up of landfill gas extraction well on North Mound: *[facing north, from top of mound]*.

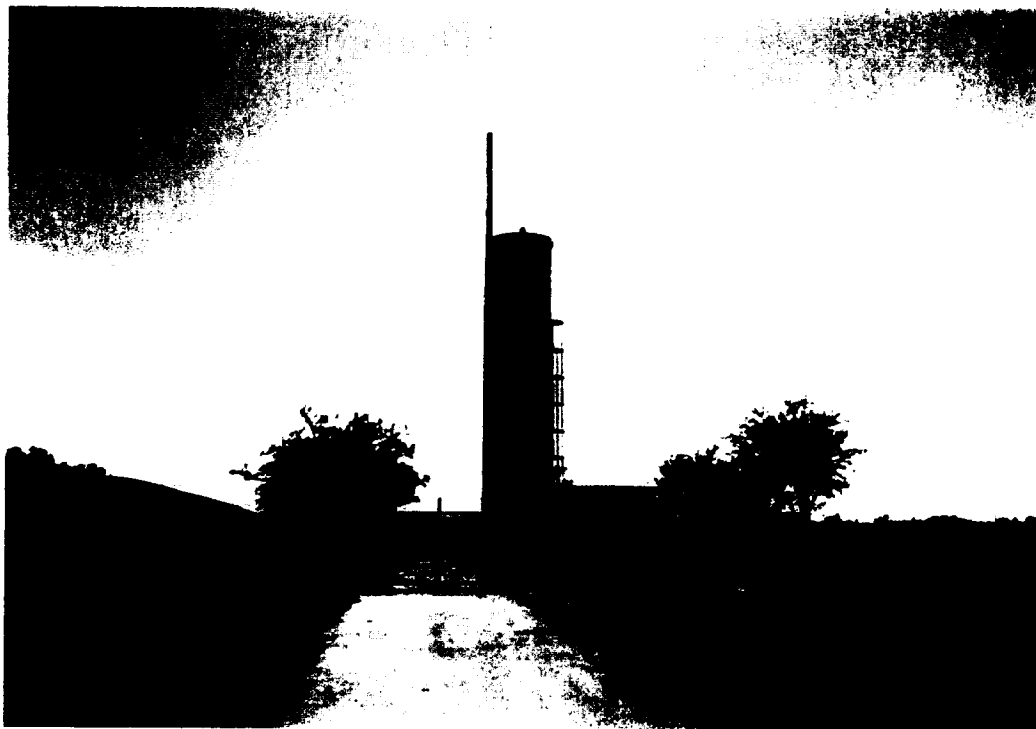
Photograph #9

Description: The DLS flare system, locked and secure: *[facing south, along western border]*.
